CIVIL AERONAUTICS BOARD

ACCIDENT INVESTIGATION REPORT

UNITED AIR LINES, INC.,—FORT COLLINS, COLORADO, JUNE 30, 1951

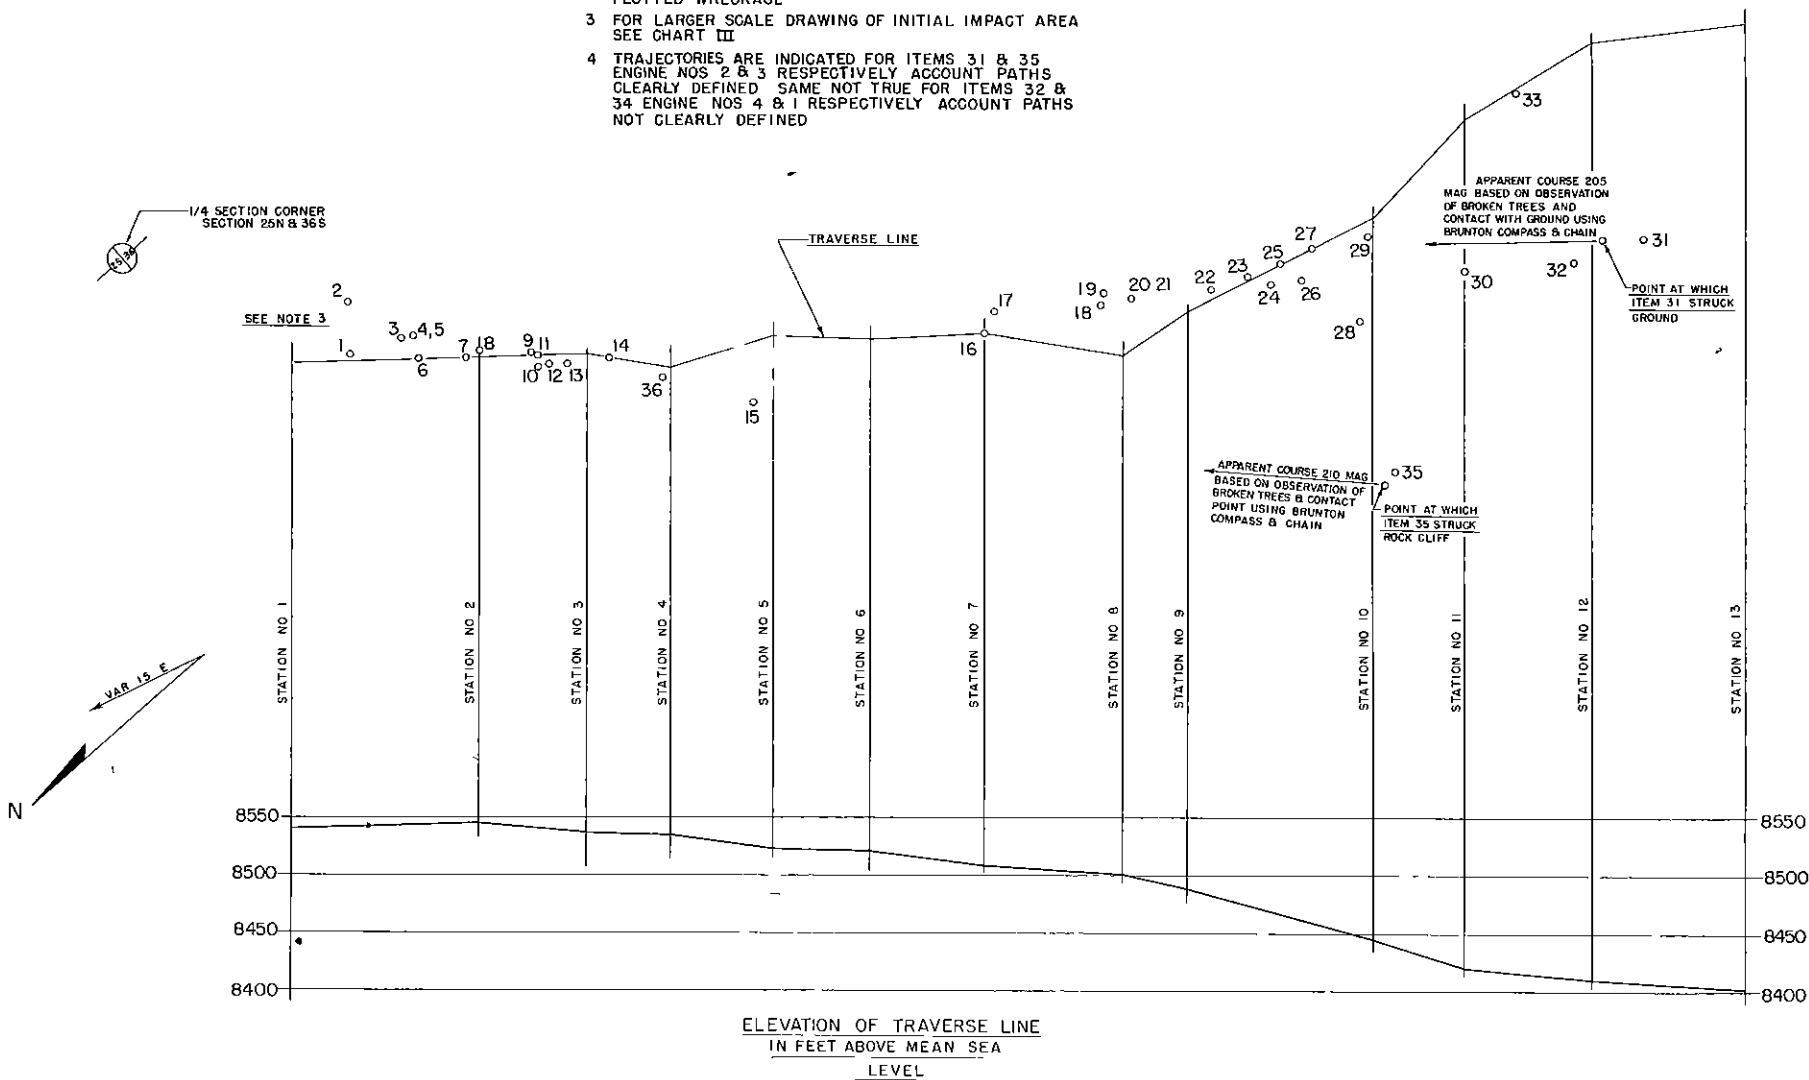
CHART II - DISTRIBUTION OF WRECKAGE
UNITED AIR LINES ACCIDENT
DC-6 N37543 AT CRYSTAL MOUNTAIN
NEAR FORT COLLINS COLORADO JUNE 30 1951

traveled in a straight line 225 feet, then bounced into the air again, and came to rest 465 feet farther on. The aircraft was demolished, and aircraft parts and assemblies were strewn over a 1,400-foot area.⁵ Localized fires occurred after impact.

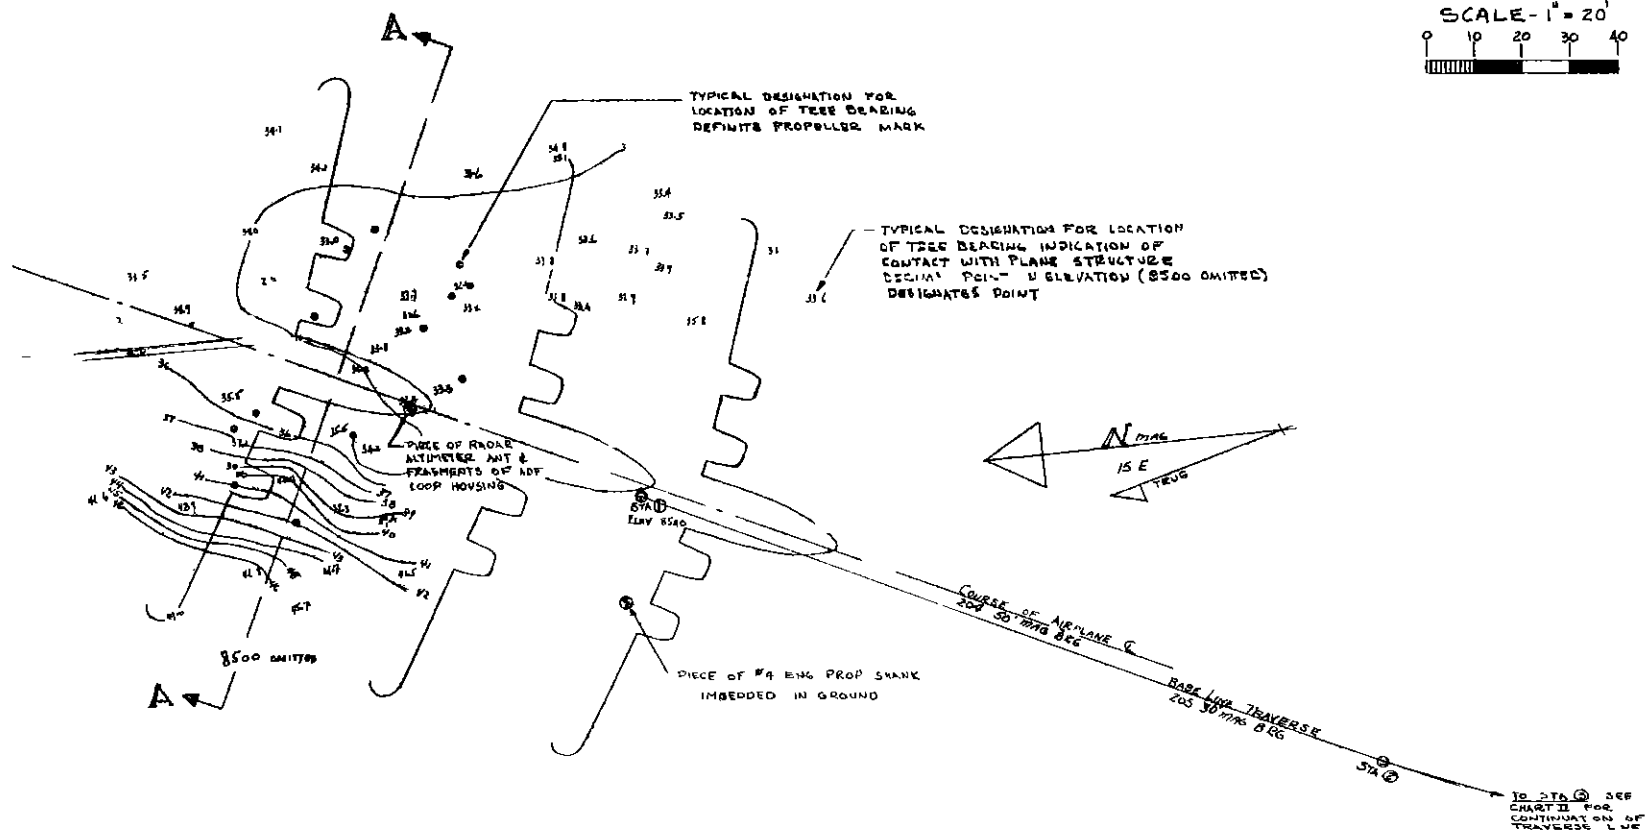
CHART III-INITIAL IMPACT AREA

Investigation disclosed from the direction of the swath cut through the trees that the aircraft struck the side of Crystal Mountain while flying with its left wing low and on an approximate magnetic heading of 210 degrees. The altitude at the point of impact was found to be 8,540 feet MSL. After initial contact with the trees the aircraft continued to travel approximately sixty feet, at which point it struck the ground. From here it

SECTION REPRESENTS LOWER SURFACE
OF DC-6 AIRPLANE FROM WING TIP TO
WING TIP AND ITS DISPLACEMENT FROM
A LINE PARALLEL TO HORIZON AS
DETERMINED FROM BROKEN TREE TOPS

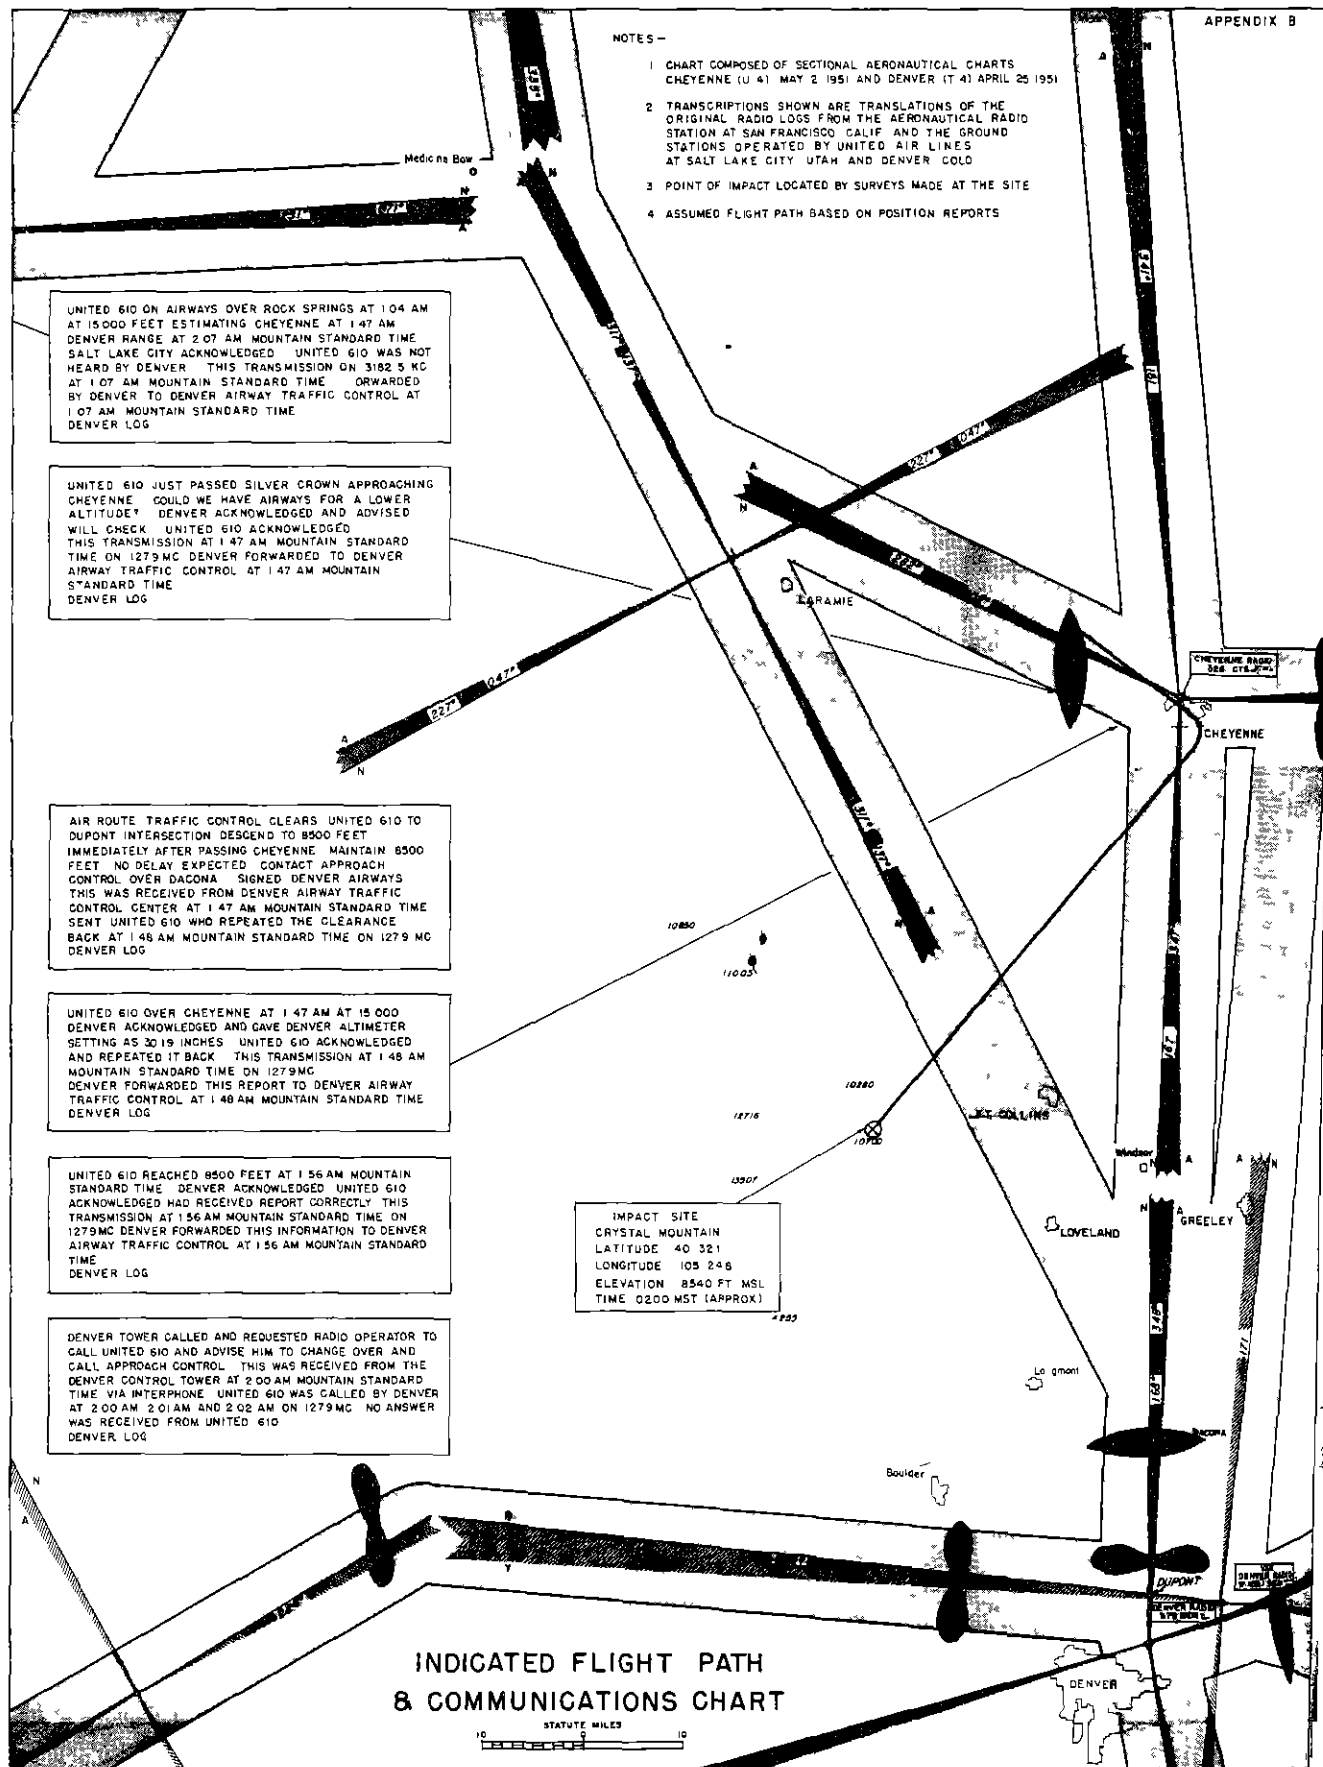
INDICATED FLIGHT PATH
& COMMUNICATIONS CHART

5 The flight crossed the Cheyenne range station at 15,000 feet and then executed a right turn to a heading of 210 degrees magnetic, descending to 8,500 feet

6 The 210 degrees magnetic heading was maintained until the aircraft struck the mountain

The Board determines that the probable cause of this accident was that, after passing Cheyenne, the flight for reasons undetermined failed to follow the prescribed route to Denver and continued beyond the boundary of the airway on a course which resulted in the aircraft striking mountainous terrain

IMPACT SITE
CRYSTAL MOUNTAIN
LATITUDE 40 321
LONGITUDE 105 248
ELEVATION 8540 FT MSL
TIME 0200 MST (APPROX)
